Support Bulletin-SB-25-10042

Title: 511-1051 KZ TX2 Agitation Valve Plumbed Incorrectly

Product Line: FAS

Model: Liquid Systems

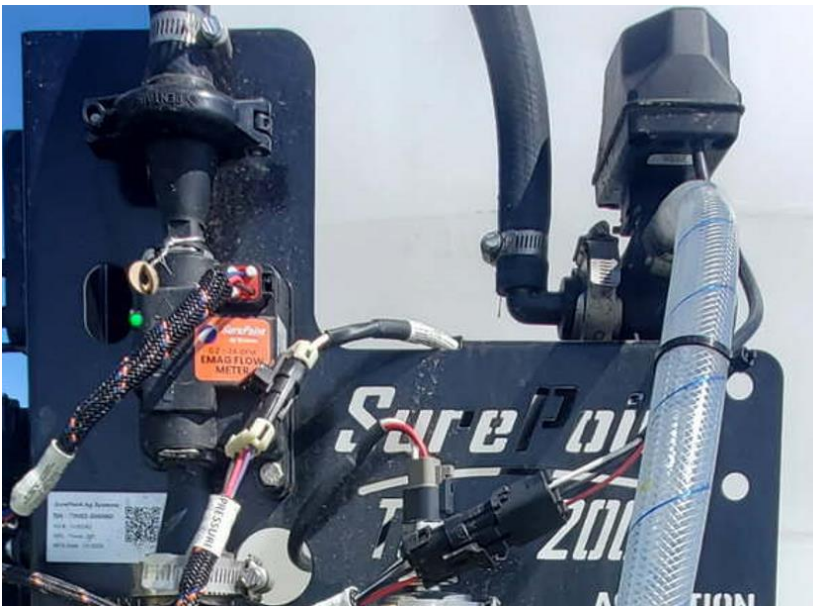
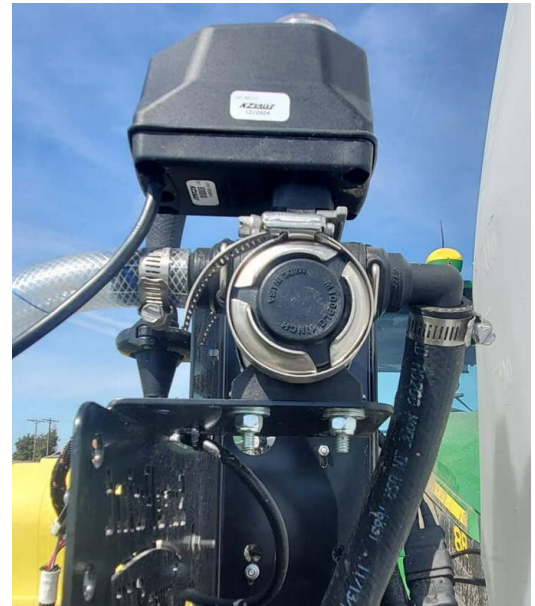
Incorrect Plumbing of Valve

Overview: SurePoint Ag has been plumbing the 511-1051 KZ TX2 constant agitation valve kit for Tower 200 incorrectly per SPA assembly. We've been plumbing the hose barb outlet that is supposed to go to rows back to the tank instead for agitation. We then plumb the tank port of the valve to the rows. We took a service call this week and the customer stated he showed 1.5 GPM of flow, but it was not coming out at the rows. After receiving pictures from the customer, it was found the KZ valve was plumbed incorrectly from SurePoint.
